PROPERTY INSPECTION REPORT

LOCATION: 123 Sample Street
San Diego, CA

Job number 0101021

January 2, 2001

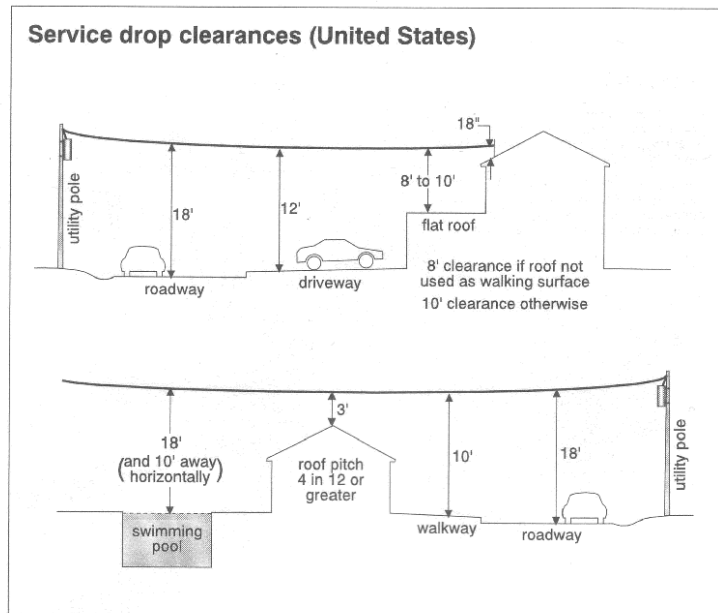
The service was overhead with 3 lines, 120 volt, 240 volt. Circuit breakers were used. **OVERHEAD WIRES:** The conductors were too close to the ground. The wires should be at least 10' above ground or any walking surface.**(C)**

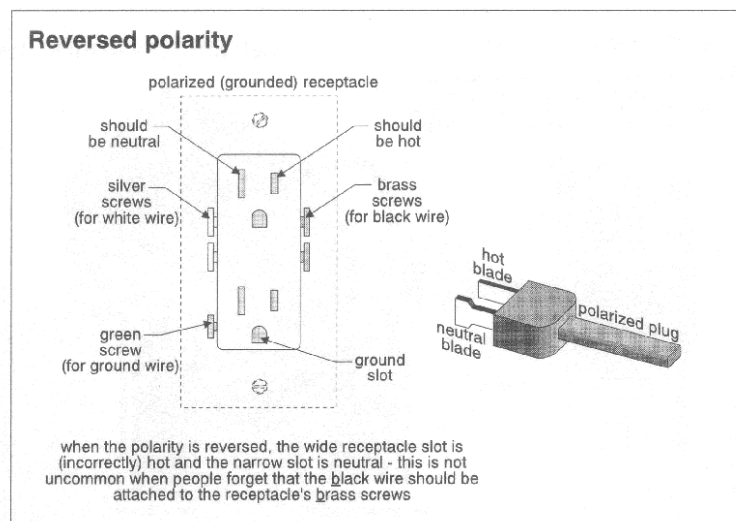
OUTLETS: Reversed polarity (wires are switched at the connection) was found at kitchen. **(C)**
